Navajo Abandoned Uranium Mine

Site Screen Report

Manuel Denetsone No. 2 AUM Site

January 2011

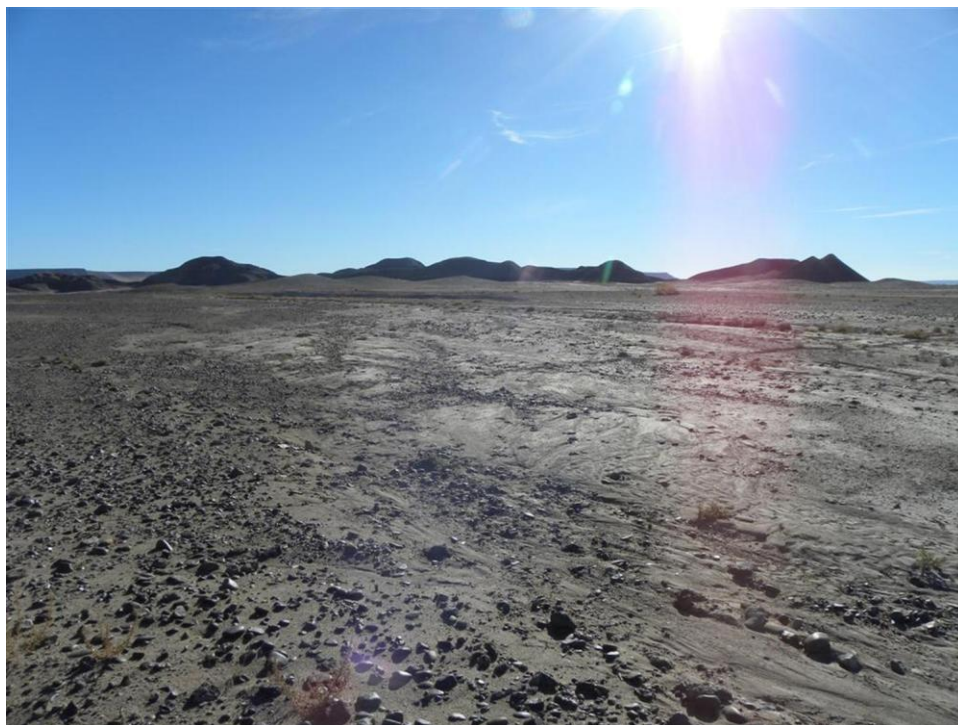
Photo 1. Manuel Denetsone No. 2 mine site

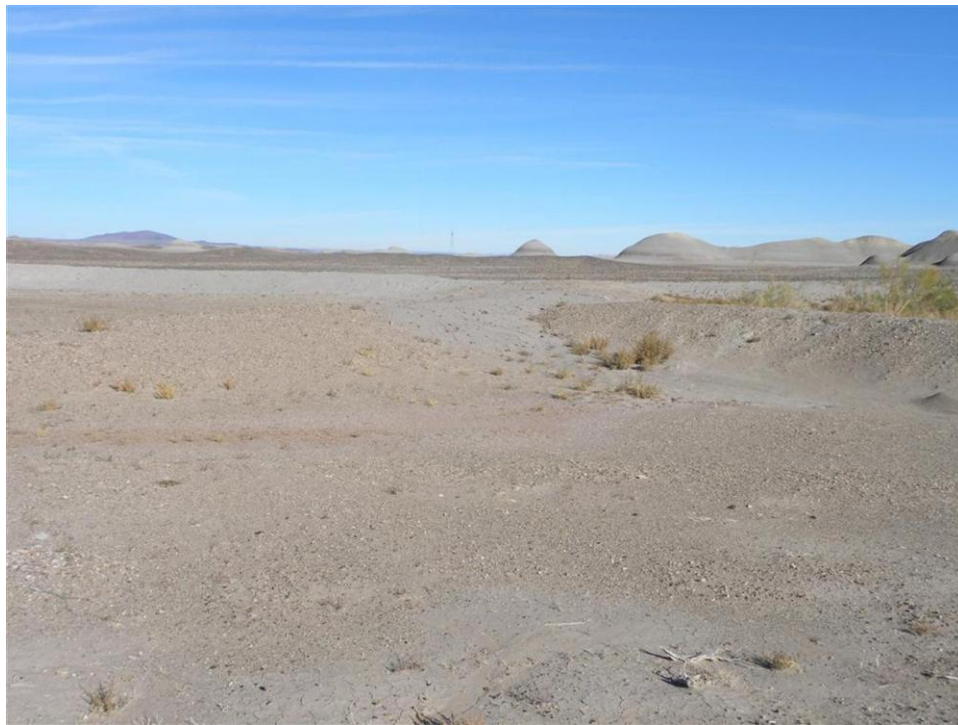
Reclamation cap, in good condition, few erosion cuts, berms for erosion control

Photo 2. Manuel Denetsone No. 2 mine site, reclamation area

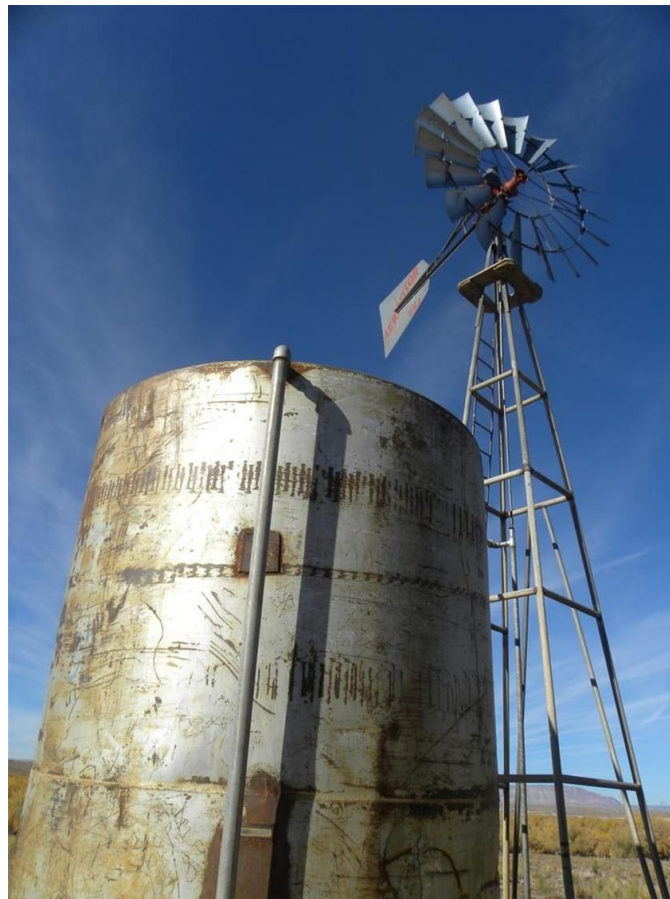
Photo 4. Manuel Denetsone No. 2 mine site, well/tank approximately 0.25 mi southwest of site
